Damage to Roadway Infrastructure from 2016 Central Italy Earthquake Sequence

Maria Giovanna Durante,^{a)} M.EERI, Luigi Di Sarno,^{b)}
Paolo Zimmaro,^{c)} M.EERI, and Jonathan P. Stewart,^{c)} M.EERI

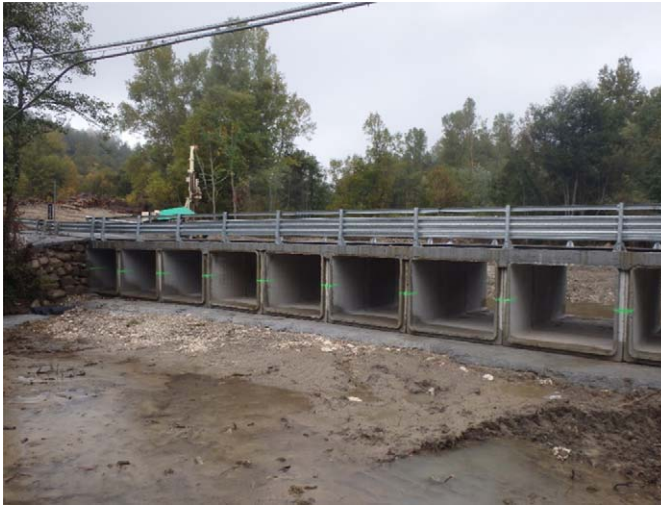
Figure 12. Temporary bridge bypassing the *Ponte a Tre Occhi* in Amatrice (Mr. Totaro, personal communication).

As a result, a joint group formed by the National Civil Protection and the Italian Army built two temporary bridges within 10 days of the 24 August 2016 main shock. The first temporary bridge (Figure 12) was built to bypass the *Ponte a Tre Occhi*. The temporary bridge was built rapidly and traffic was opened within one week of the main shock. The construction of this temporary bridge started with a diversion of the river that allowed the construction of a concrete sublayer slab on the river bed and a placement of ten 3×3 m precast concrete void elements. Those elements were selected to allow the restored river flow to pass through them. Vehicle loads were distributed over the vertical webs of the precast elements through a cast *in situ* deck slab.

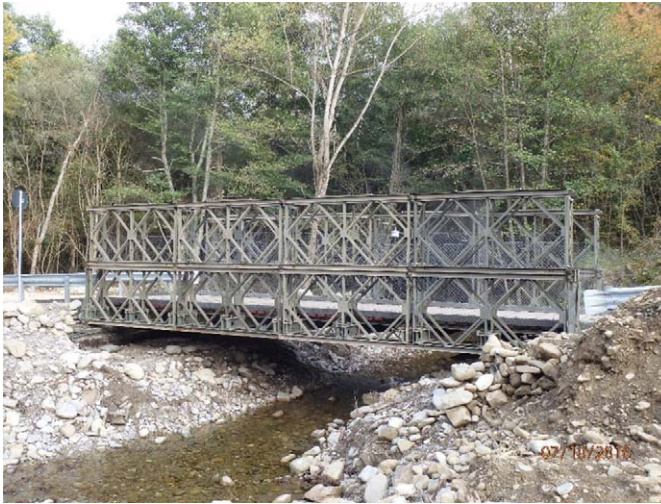
Figure 13. Temporary bridge near *Ponte Rosa*.

The second temporary bridge (Figure 13) was built to increase traffic capacity of the east access road and overcome traffic restrictions resulting from partial closure of the *Ponte Rosa*. It is a 12-m span Bailey bridge, a typical military construction typology that can be deployed quickly. This bridge is a modular construction, covering relatively small spans by assembling preformed steel frames connected into truss beams. Two truss beams are connected by transverse steel beams forming the deck and the bridge parapets.
